Matlock Bank

Conservation Area Appraisal

8. Negative Factors

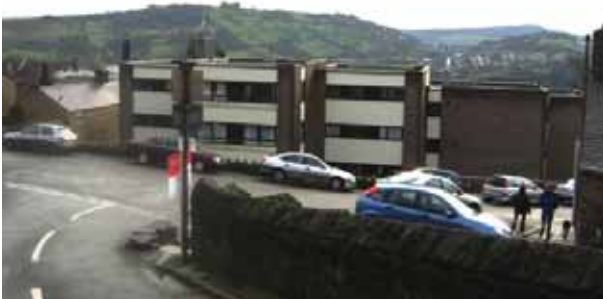
View of High Court from Jackson Tor Road

In general, much of the mid to late twentieth century development has a neutral effect on the character of the area, but there are a few cases where individual buildings are very conspicuous, jarring visually with the surrounding context. One of the clearest examples of this is the High Court residential development off Smith Road. When viewed from the junction of Jackson Road and Jackson Tor Road above the massing of the building is a barrier, blocking the views across the valley. From a little further up the hillside, it stands out distracting the eye from more pleasing landmarks such as Riber Castle and Smedley's 'crown' to County Hall. The building is a wide, expansive, flat-roofed block, with horizontal bands of white "ship-lap" cladding and vertical piers of blue brick, all features that do not sit comfortably with the soft tones of the surrounding stone and

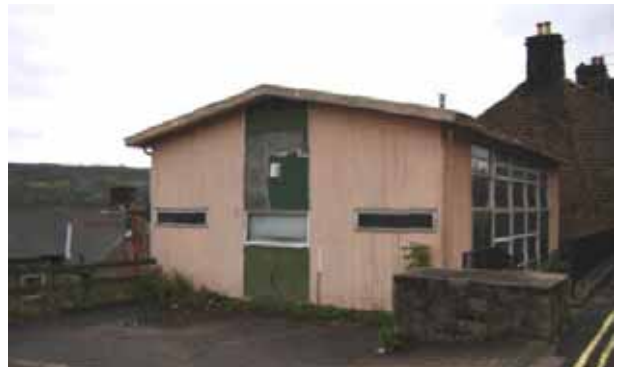
Prefabricated hall, Jackson Road

slate, and the smaller scale buildings which characterise the immediate area. The nearby prefabricated hall on Jackson Road similarly stands out for its choice of inappropriate materials.

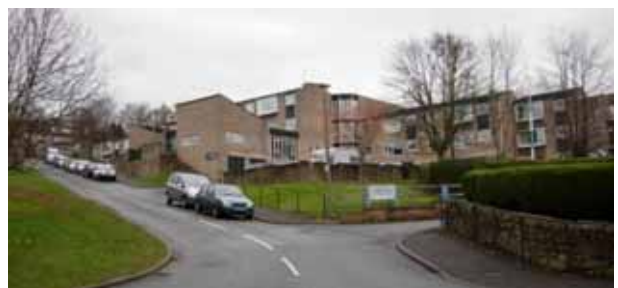
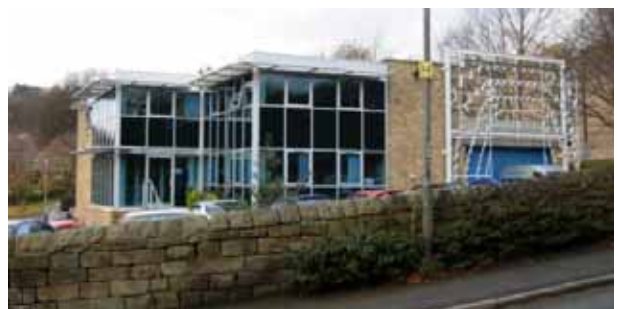
Above: Victoria Court

The Victoria Court development and adjacent Laser Rail buildings lie outside the conservation area boundary, although they affect its setting. The form of these buildings, and the way that materials are used, contrasts with the distinctive character of the conservation area. For example, the curtain glazing to Laser Rail, and the large unbroken mass of Victoria Court, with detailing such as low pitched roofs and "picture" windows, is very different from the tight grain of stone cottages and terraces with steeply pitched roofs, chimneys and the wealth of craftsmanship and detailing that is typically found within the conservation area. In this prominent location, off a major through-route, near the Smedley Street East and Chesterfield Road junction, one of the main entrances into the historic heart of the conservation area, the impact on the setting is a negative one.

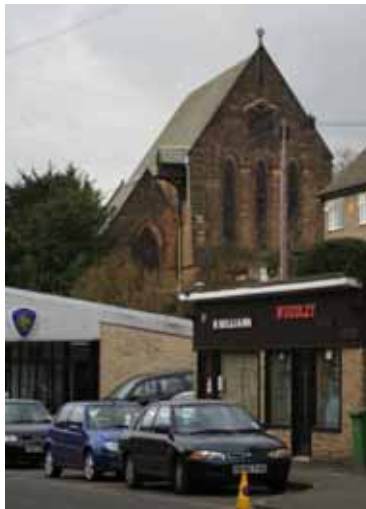
Two commercial properties on the north side of Smedley Street are particularly damaging to the views of All Saints Church above (right). Built from unsympathetic materials, they introduce distracting garage paraphernalia, large signs and unsympathetic boundaries.

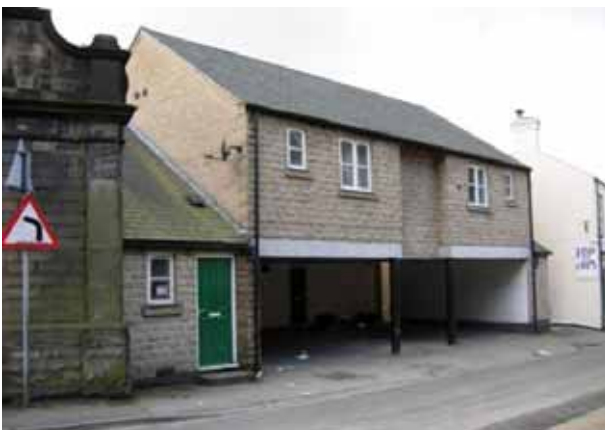
28 Wellington Street incorporates an undercover carport at ground level. The lack of an active frontage and interest at pedestrian level, coupled with the appearance of top-heavy development, is inappropriate streetscape in any area, not just in an historic setting.

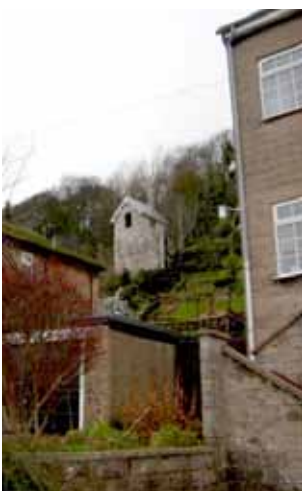
Development on a minor scale can also have a visual impact. The freestanding tower in the garden of 6 Jackson Tor Road is prominent from the public footpath between Cobden Road & Jackson Tor Road, as well as from Jackson Road below (left). Its unusual slender and tall proportions, and concrete blockwork construction draw attention, although once the blockwork is clad in stone its prominence will be reduced.

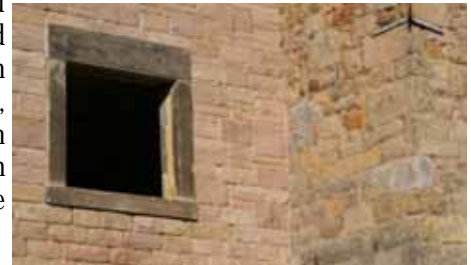
The way in which materials are used is as important as the material itself and traditional building techniques are part of the character of the settlement. For example, a recent extension to a 19th century building on Wellington Street (pictured below) has failed to match the original stonework (on the right hand side of this image), as the stone selected for the upper walls is quarry-dressed, squared ashlar, laid as broken courses, rather than random rubble stone.

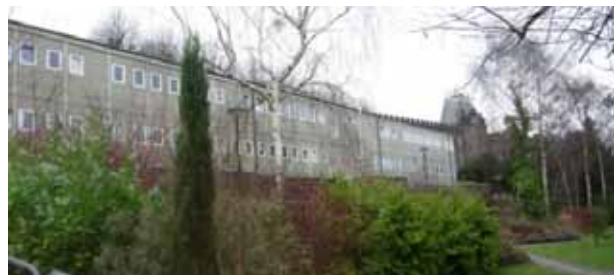
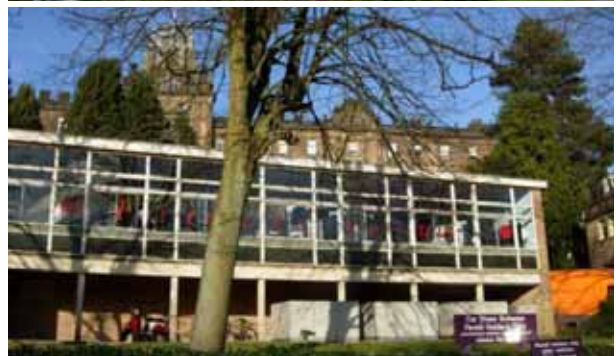
County Hall (former Smedley's Hydro), has several outlying buildings on the site which do not relate well to the original block, but are at least masked by the tree canopy in distant views. This is not the case, however, with later blocks clearly visible from Wellington Street on the Chatsworth Hall (former hydro) site.

Above: two images of blocks obscuring the west wing of County Hall

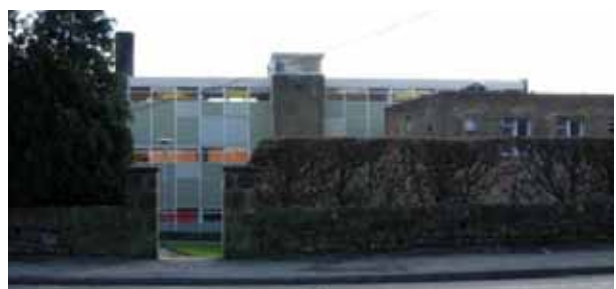
Below: mid twentieth century block on the Chatsworth Hall site

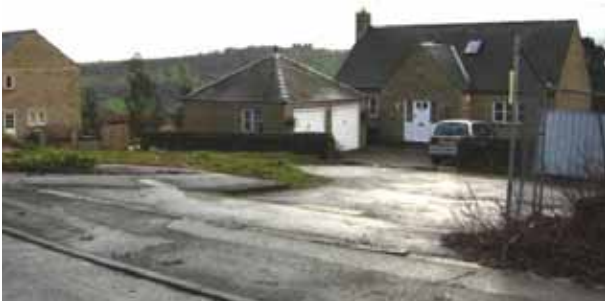
The lack of boundary wall to the street frontage of this late twentieth century house on Cavendish Road does not follow the character of the conservation area

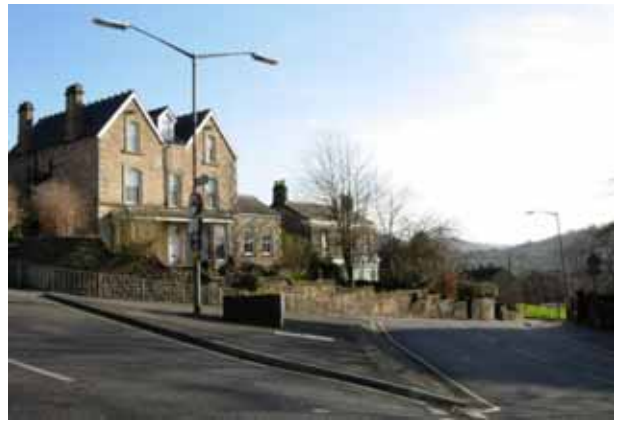
Traffic island at the junction between Chesterfield Road and Smedley Street East

The slope of the hill and the nature of the road layout have resulted in a number of wide, expansive road junctions, often with little focus. The junction between Chesterfield Road and Smedley Street East is an important gateway into the conservation area. Unlike most other junctions, this one has a traffic island presenting a platform which could be used to create a focal point, but in this case is a missed opportunity with a street lamp cluttered with signs and a relatively small rectangular planter.

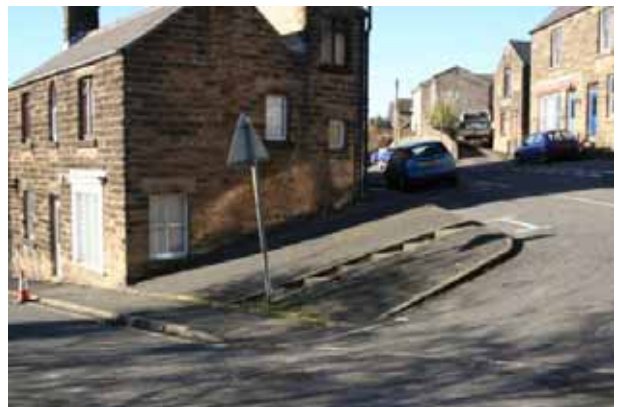
Corner of Jackson Road and Wellington Street

Other examples of neglected road junctions include the corner of Smith Road and Jackson Road and the corner of Jackson Road & Wellington Street. Concrete kerbs and large expanses of tarmac dominate these junctions.

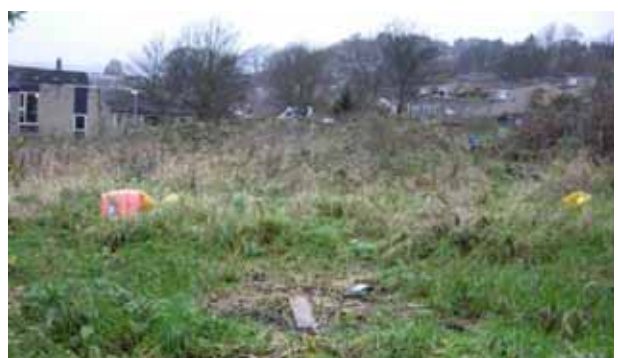
Whilst most public spaces and parks are very well maintained, the open space adjacent to Chesterfield Road, which leads towards the allotments, appears to be a neglected wasteland with an accumulation of fly tipping visible from the roadside, creating a negative impression (below).

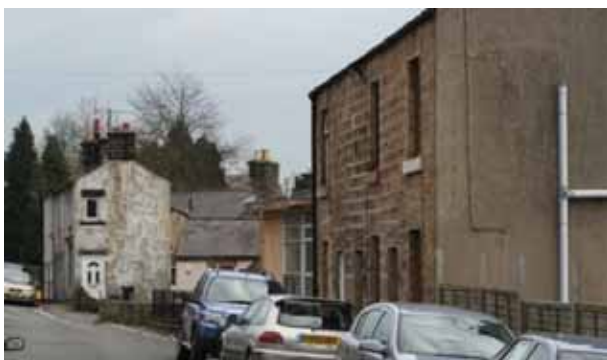
With the exception of a few Arts and Crafts properties, render is not generally a common feature within the conservation area. Where render has been used, the bright, white-painted finishes and the uniform cementitious materials stand out uncharacteristically within the conservation area. The neutral and ochre-coloured traditional “wet-dash” and “wood-float” renders of properties, such as No. 6 Cobden Road and 15 Jackson Road, are less noticeable and less garish.

The neutral colour to render in the foreground is less visually obtrusive than the white render in the distance

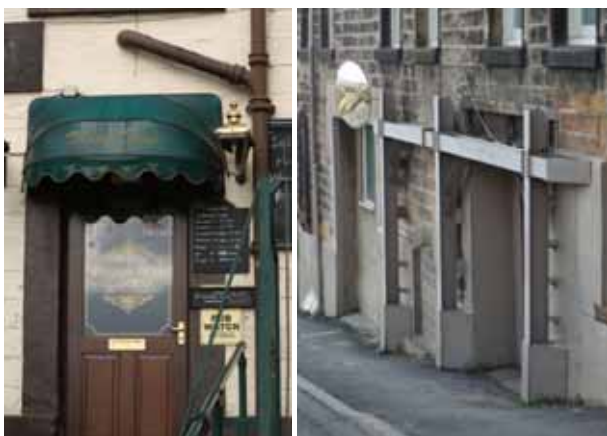
Above left: Features such as blinds, signs and light fittings, intended as ornamentation to facades, can become visual ‘clutter’ when used to excess.

Above right: In the case of Chatsworth Hall, measures to counter structural defects detract from the building

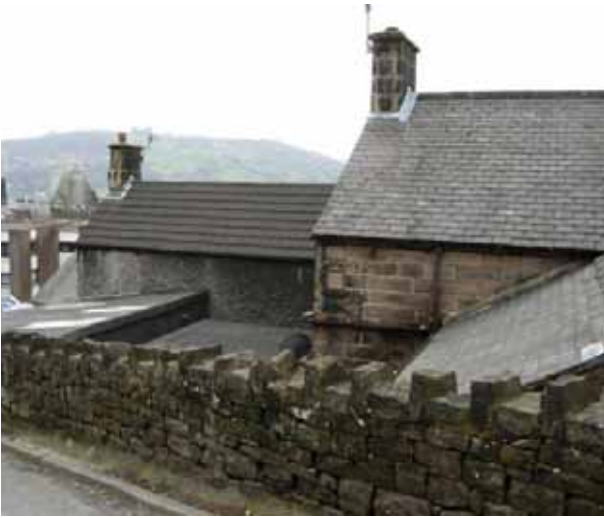
The unusual circumstances where pedestrians look down onto roofs in the streets below makes changes in roof coverings all the more noticeable. There are instances where concrete roof tiles have replaced both Welsh slate and Derbyshire stone slate and these detract from the character of the conservation area.

The contrast between roof materials can be seen clearly here. The older Welsh slate roofs with a natural variation in colour are on the right and the later concrete tiles on the left are larger and thicker and more regular in colour and profile

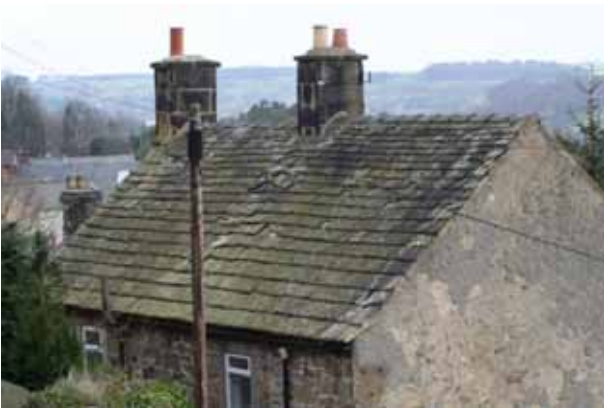
The overall condition of buildings and open spaces in the conservation area is generally very good. In order to ensure retention of historic fabric, 'prevention is better than cure' and maintenance is very important. There are examples where lack of maintenance threatens loss of historic fabric within the conservation area, such as the stone slate roof at 6 Cobden Road, now in very poor condition (below).

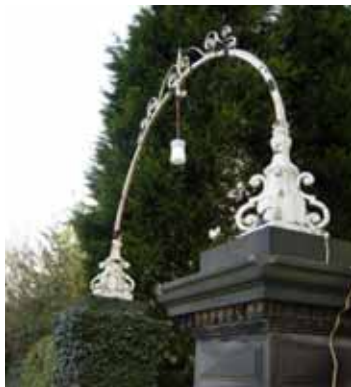
The arched wrought iron lantern holder at Chatsworth Hall (former hydro) adds great interest to the entrance. Features like this are worth keeping in good repair to avoid corrosion of the metal-work

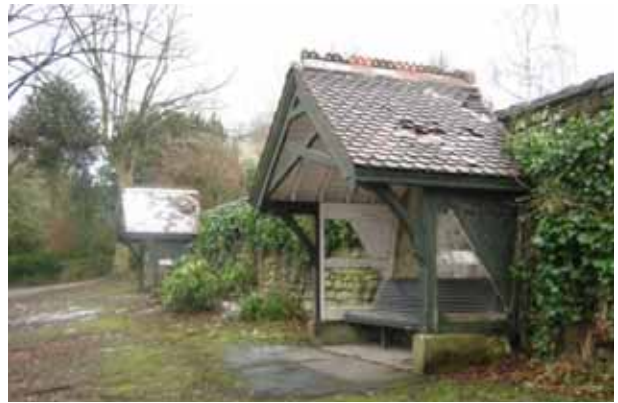
Sadly the covered seating areas in the gardens at County Hall are one of the few surviving remnants of Smedley's hydro grounds, and are deteriorating rapidly

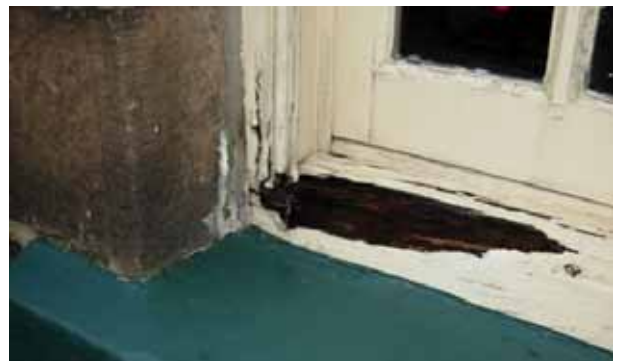
This timber cill has been allowed to rot to the point where a substantial amount would need to be replaced to obtain a good repair. Original joinery is well worth maintaining as it is likely to be of a higher quality than the timber available for windows today

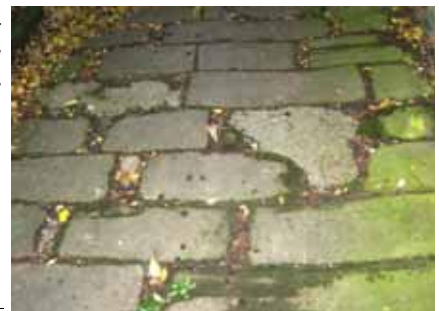
Surviving stone flagged and setted surfaces are at risk from patch repairs in tarmac
