## ARCHITECTURAL & HISTORIC QUALITY

# Conservation Area Appraisal

## Qualitative Assessment

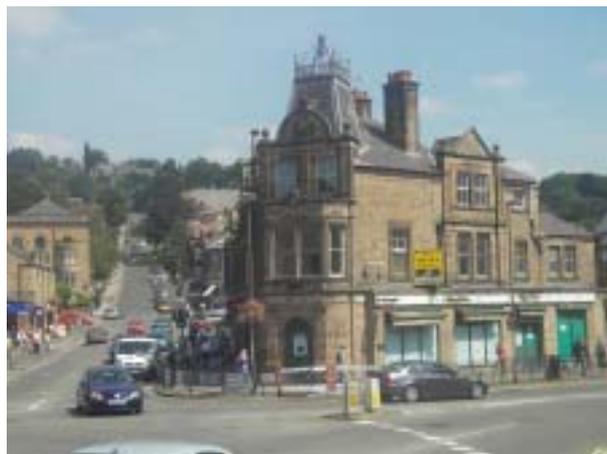
*Crown Buildings*

This distinctive and highly modelled corner building dates from 1889. The elevations are of ashlar stone with roofs of Welsh slate. The dominant feature is the three storey stepped and chamfered corner which is surmounted by steeply sloping “turret” style roof with decorative cast iron crestings and finials. An asymmetrical 4-bay elevation faces onto Causeway Lane, the last bay of which steps down to 2-storey in height to blend in scale with the neighbouring buildings. The return elevation on Bank Road is longer at 7-bays, and although also of asymmetrical design, it is of greater architectural scale and formality. The ground floor provides retail

accommodation characterised by large shop fronts, with the upper floors used as offices and storage.

The distinctive corner which breaks forward as a single bay, houses the main ground floor entrance. The doorway has a semi-circular head with expressed keystone and is flanked by several orders of pilasters. The timber door is not original. Either side of the doorway, on the curved corners of the bay are bas-reliefs depicting a crown.

The south elevation facing onto Causeway Lane is of 4-bays. Bays 1 to 3 are 3-storey in height whereas bay 4 is 2-storey. The second bay breaks forward from the façade to rise above eaves level and is surmounted by a triangular pediment with urns. At ground floor are modern shop fronts of a former retail outlet. Original timber fenestration survives at first floor level, uPVC has been inserted at the second floor level.

The return west elevation facing on to Bank Road is of 7-bays. The ground floor has been much altered by the insertion of modern shop fronts. There are further entrances off Bank Road to these retail units and upper floor accommodation. At first floor level bays 1, 3 and 5 contain oriel windows. Alternate bays rise above eaves level and are surmounted by triangular pediments. Much of the original fenestration survives at first and second floor level although modern louvered panels and uPVC windows have been introduced into a number of openings.

The roof is covered with Welsh slate and is surmounted by 2 large stone chimney-stacks with clay pots. Generally, the roof is in fair condition. However, the rainwater goods are extremely poor with many of the cast iron gutters and downpipes damaged or missing. This is unfortunately allowing water to soak into the building fabric and cascade onto the pavement below.

At the time of this appraisal, the units facing onto Causeway Lane and some of the upper floors are unoccupied which gives an air of neglect.

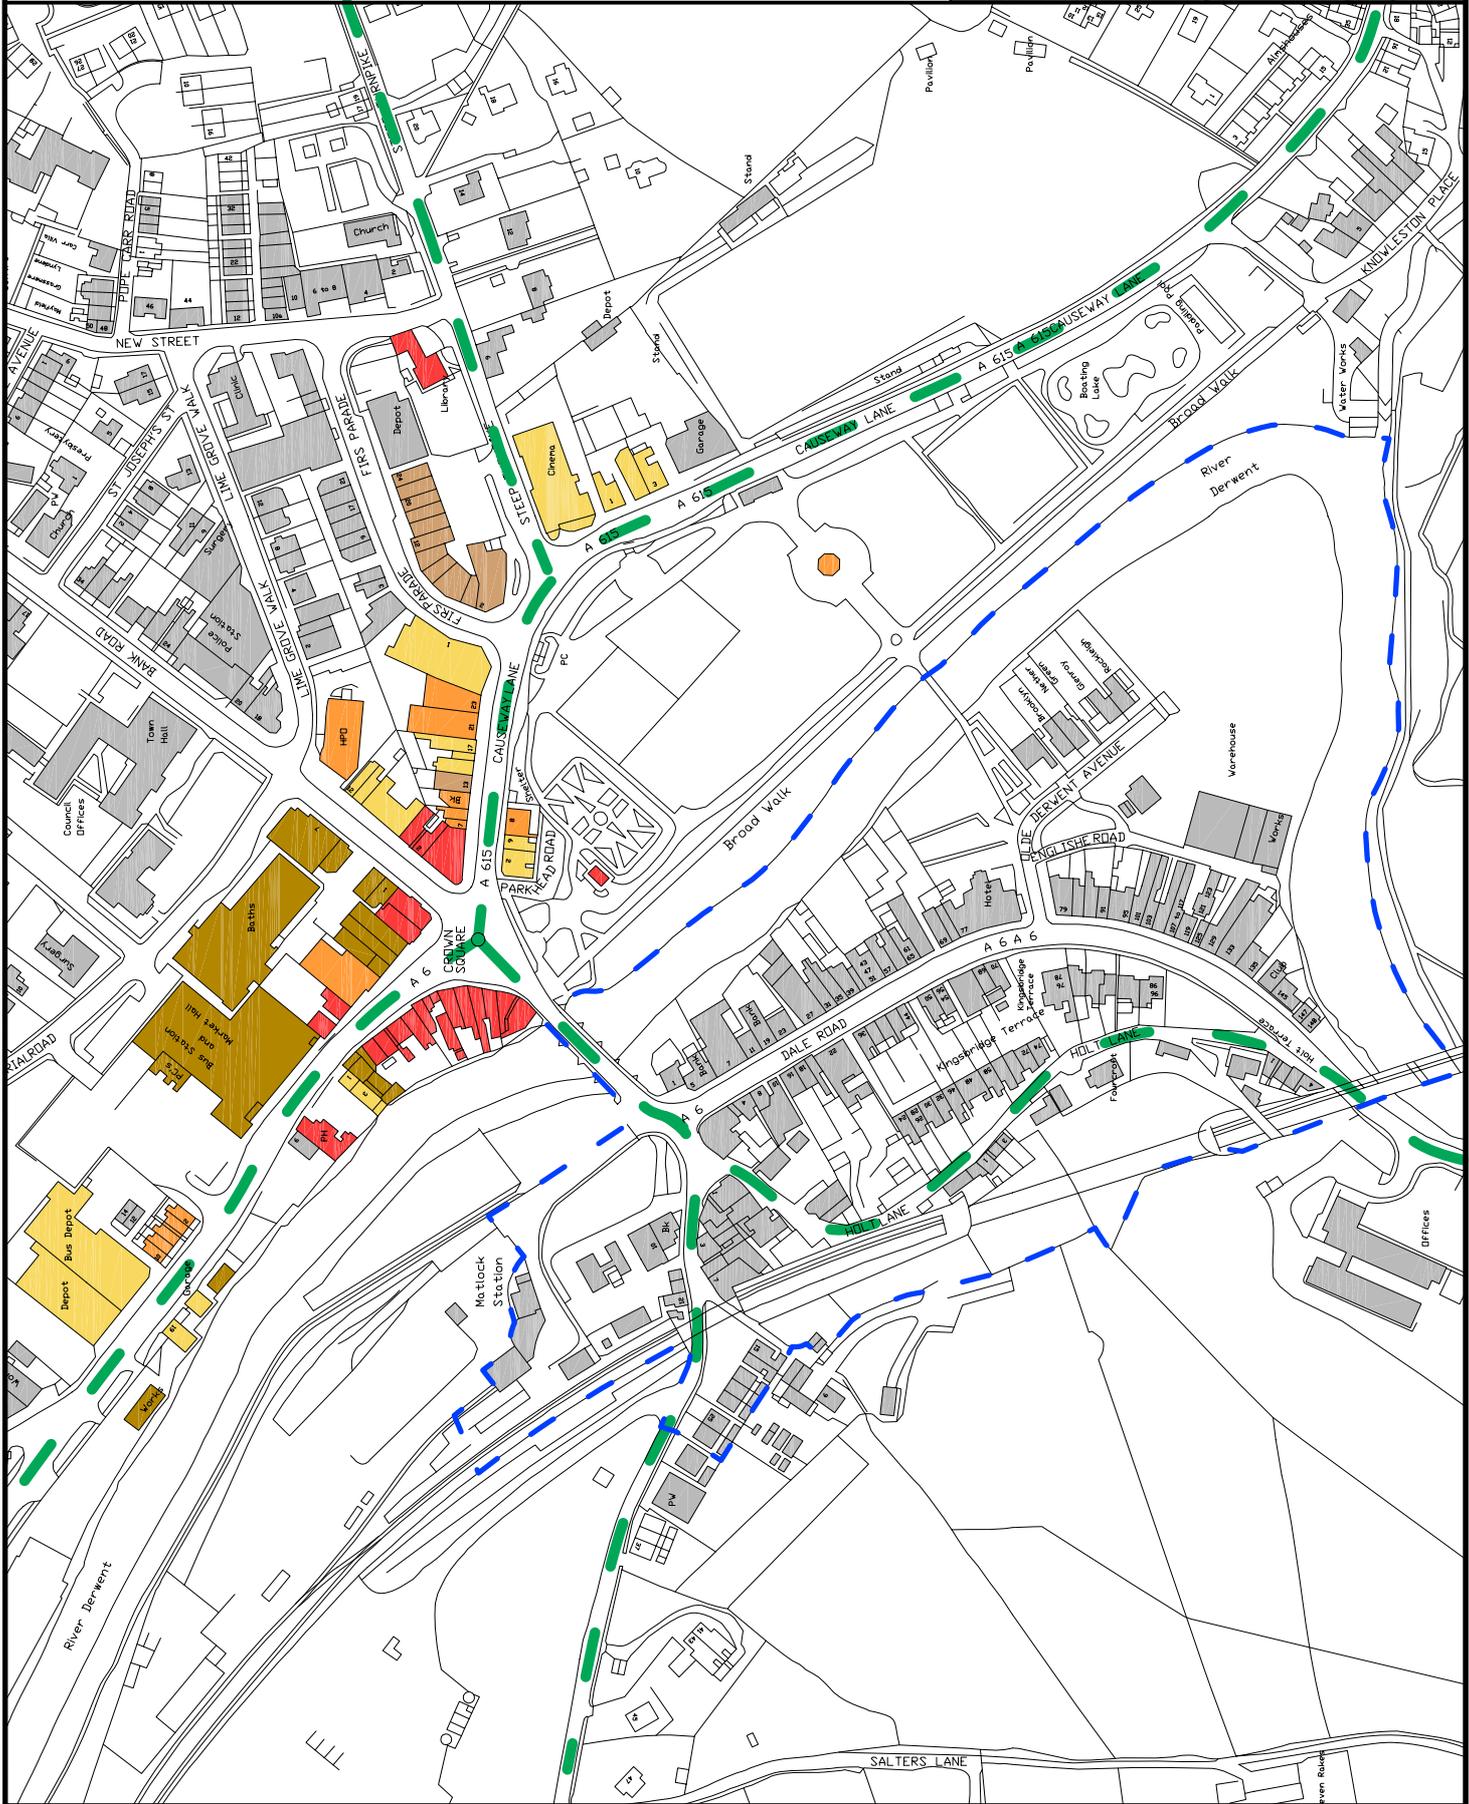
Figure 7

Building Development Periods

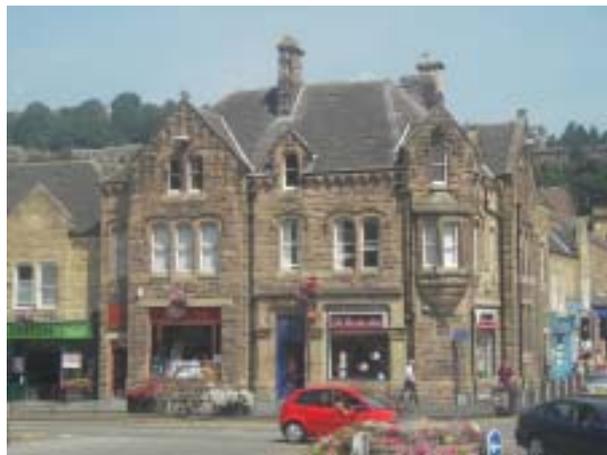
*No. 3 Crown Square*

Standing on the opposing northern corner of Bank Road is the former Crown Hotel. Although less ornate than Crown Buildings, this 3-storey building is an impressive architectural feature of Crown Square, with the two buildings providing an imposing entrance to Bank Road. The building is constructed of rock-faced gritstone with stone dressings under pitched roofs of Welsh slate. The roofs are surmounted by three stone chimney-stacks. The elevations are well modelled with a number of gables breaking the line of the eaves. The principal architectural feature is the stone oriel window on the corner of Bank Road and Crown Square with its decorative carving and bas-relief of a crown on the wall below.

The upper floor windows have curved heads with decorative hoodmolds with the second floor having a number of half-dormers. Stone corbels support the cast iron eaves gutters.

The former hotel stood in a landscaped forecourt but this has now been lost during traffic engineering works to Crown Square with the building now standing on the line of the pavement. A recent 2-storey extension has been built along Bank Road; although of matching details and materials its appearance is slightly incongruous due to its smaller scale. The roof appears to have been recovered in artificial slate. A number of lead hips are missing allowing water to enter the roof.

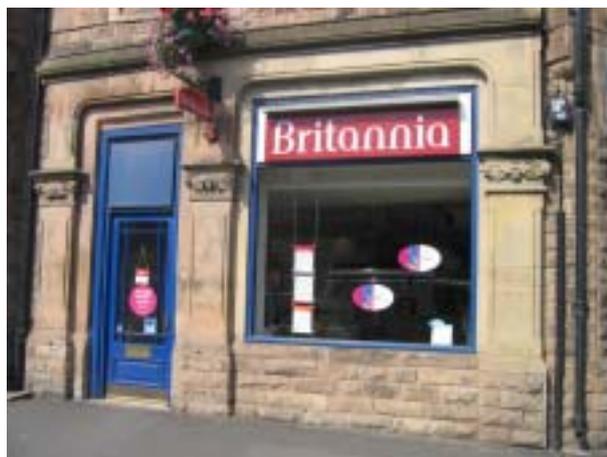
*Inserted shop-front in No.3 Crown Square*

Close scrutiny of the building and reference to historic images reveals that it has undergone substantial alteration during the 20<sup>th</sup> century, with large shop front openings inserted at ground floor and the principal entrance onto Bank Road with its feature glass canopy being lost.

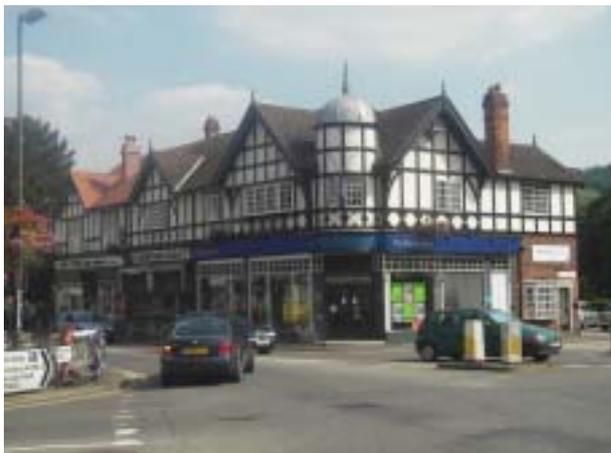
*Derbyshire House*

This Neo-Tudor property at Park Head is immediately recognisable by its black & white half-timbered upper storey which lends the building a pavilion-type character. This 2-storey building provides a focus to Crown Square at the junction with Causeway Lane and does so by addressing both street frontages with a corner turret acting as a visual pivot. Whilst of complimentary scale and massing to

Derbyshire House dates from the 1920's and was constructed when Park Head was redeveloped. Works at this time included the demolition of properties on the south side of Snitterton Road, opening up views to the park, and the relocation of the tram shelter.

The ground floor is constructed from smooth-faced red brick with large shop front openings onto Crown Square and Causeway Lane. The rear elevation onto Park Head Road contains few openings. The upper storey is of timber and painted render with large multi-paned windows. The distinctive corner turret provides a ground floor entrance and is topped by a lead covered dome with ball and finial detail. In contrast to its neighbours, the roof is covered with clay plain tiles. Of historical interest is the elephant motif to be found on the rear gable. The building formerly housed three businesses, Eldridges, Burgons (a provisions merchant) and the Derbyshire Times. The elephant was a logo for Burgon's shop's own brands.

It is of interest to note that Derbyshire House is of two builds. This can be more clearly seen to the rear of the building where a vertical straight joint and slight change in roof-line marks the divide. The building appears well maintained and is in excellent condition.

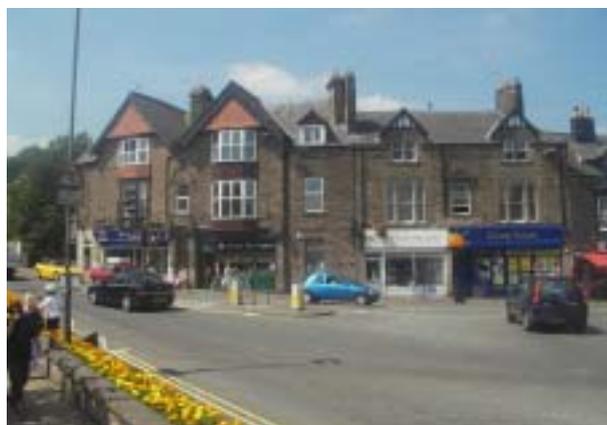
*West side of Crown Square*

The west side of crown Square comprises a series of individual, predominantly 3-storey, buildings which step down the hill from the bridge along Snitterton Road and into Bakewell Road. All are constructed from rock-faced stone with stone dressings under roofs of Welsh slate. Individually these buildings are not considered to be key, however their contribution to the character and form of the area as a group is critical to the overall townscape and architectural value of the proposed extension.

The first block adjacent to the bridge is the most recent of the group, dating from the end of the 19<sup>th</sup> century. This 3-storey Arts & Crafts style building is characterised by two large tile-hung gables which face onto the street with tall oriel bays on first and second floors. The tile hung gables are a particularly unusual feature in the context of Matlock's dominant architectural character and consequently of some note. Only one original timber sash window remains on the roadside elevation the others having been replaced in uPVC. Some of the original tile hanging has also been lost. The last bay of this elevation steps down to link with the earlier neighbouring building with the stone eaves detail replicating that of next door and the small attic dormer a further architectural reference. At ground floor stone corbels and details remain but the original shop fronts have been lost or heavily altered. The elevation facing onto the bridge and river, which is now largely obscured by trees, contains two tall canted bay windows. The roofs are surmounted by decorative terracotta ridges and stone chimney-stacks.
