Shirley

Conservation Area Appraisal

3. Archaeological Significance

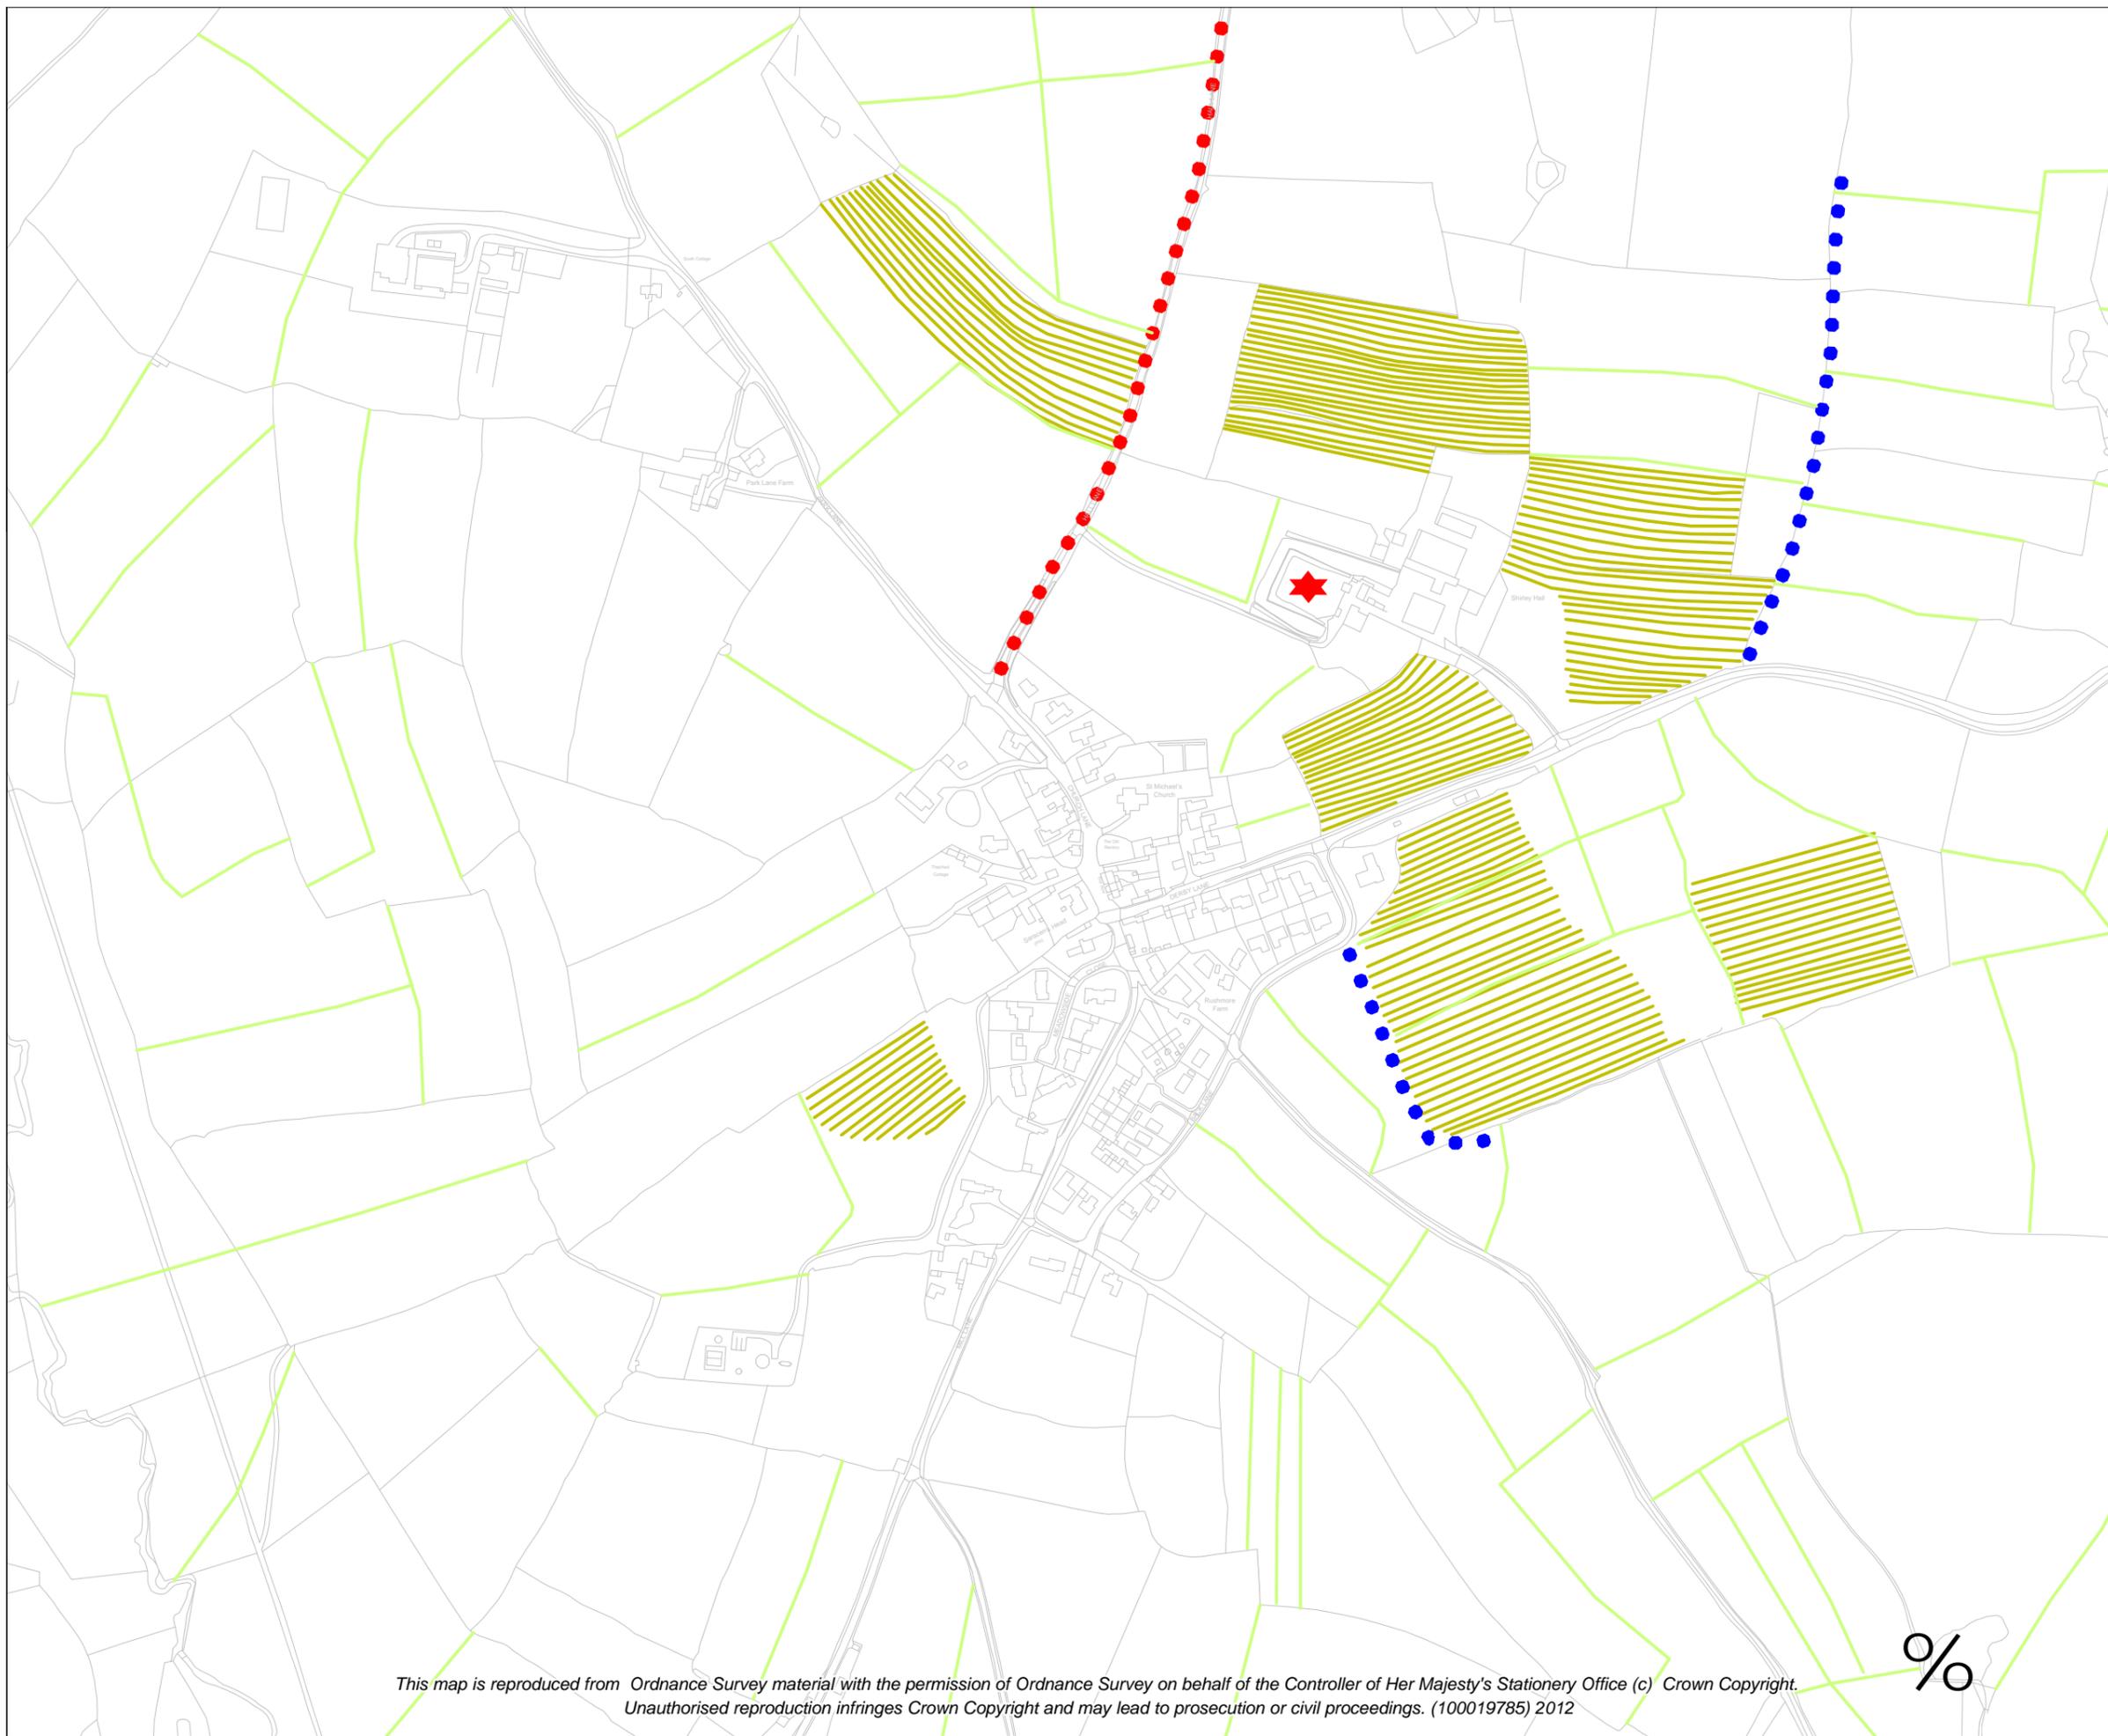
FIG 8

Hall Lane - This does not appear on the 1787 map and may therefore date from c1790 - 1820
-

Lost trackways (since 1838)
-

Lost field boundaries (since 1838)
-

Remains of ridge + furrow (as extent in 1971). Much now lost.
-

Moated site at Shirley Hall

Historic Landscape

the medieval field pattern, fossilized in the landscape with hedging. The aerial photograph of 1971 shows a small amount of ridge & furrow surviving immediately around Shirley Hall and to the south of it. Since then, however, much has been ploughed out, however, small vestiges have survived (close to Shirley Hall).

The current road & lane layout/system of the settlement has early origins and relates to the topography of the area. Many of the roads/lanes are very narrow with high sides (often referred to as 'holloways'). As a fossilized network this has some archaeological, and historical, importance to the character and appearance of the village. The Tithe map of 1838 indicates two trackways leading into the field systems, to the east of the village, which no longer survive. It is also possible that the road connecting the village to the A52 was formed between c. 1790 and 1820. This may require further research.
