Zone 2 - Dig Street

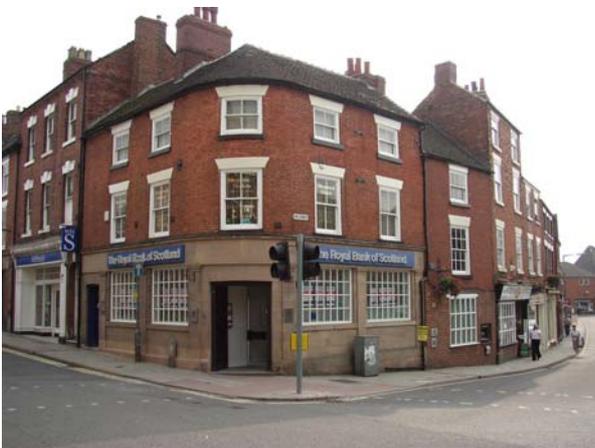
Royal Bank of Scotland – late 18th century

The Royal Bank of Scotland is located on the corner of Dig Street and St John's Street. Although a relatively plain building its rounded brick corner is an important architectural contribution to the street and is a good example of how a building can turn a corner in a sensitive and harmonious way. The building dates from the later 18th century but the ground floor has been altered in the early 20th century to suit the purposes of a bank.

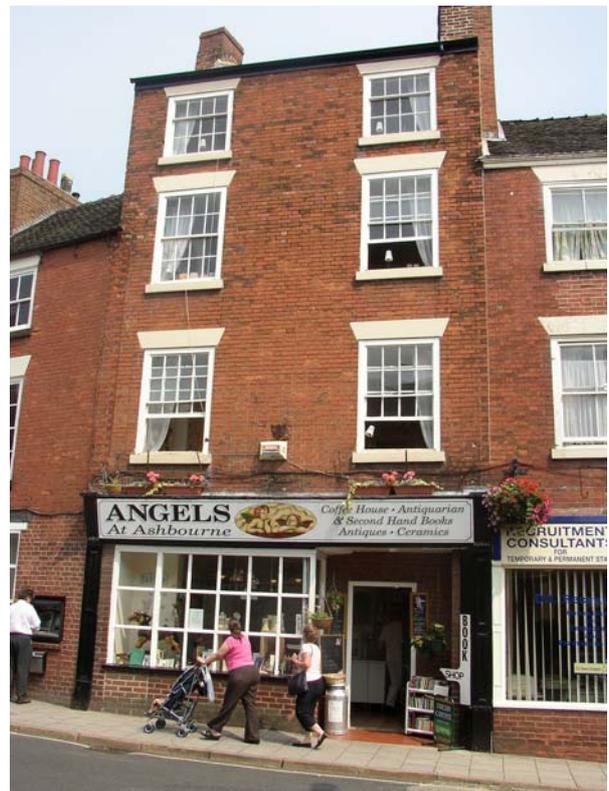
No.6 Dig Street (prior to new shopfront being installed)

Adjacent to the Royal Bank of Scotland is a four-storey building, two bays wide. In its height this is a prominent building within the street scene. It dates from the later 18th century and has multi-paned sash windows. The shop front is modern (2006) although parts of the fascia and pilasters are older (possibly late 19th century). The current shopfront was based on a photograph taken in the early 20th century.

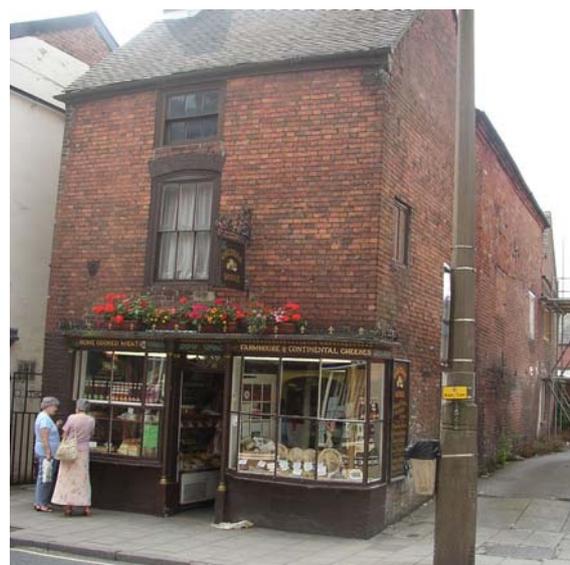
No 9 Dig Street

On the opposite side of the road to No. 6 are two properties both dating from the later 18th century. No.9 is the Delicatessen and has two projecting bay shopfront windows possibly dating from the early 19th century with collonette pilasters and an original decorative fanlight over the door. The shopfront is of particular architectural and historic value as being a surviving example of a shopfront from the early 19th century. The building itself is of red brickwork with sash windows and a tiled roof.

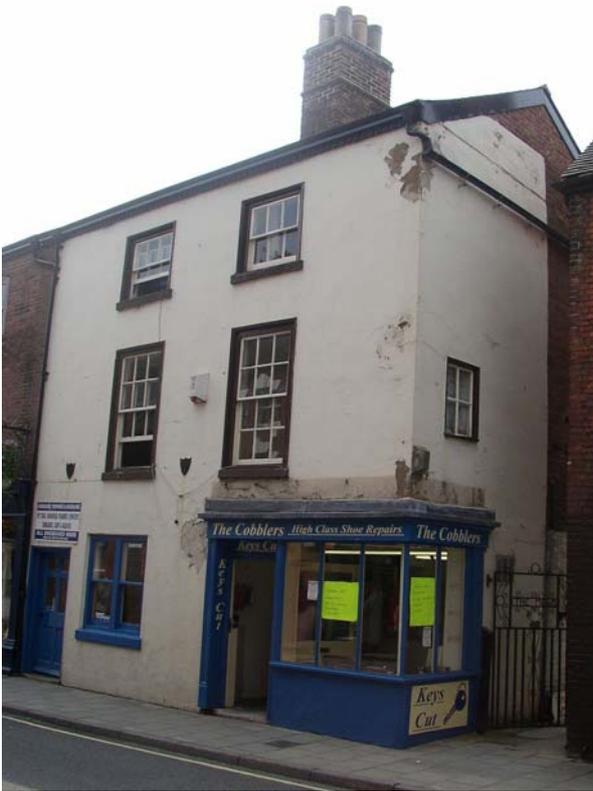
No 11 Dig Street

Adjacent to No. 9 is No. 11, this has an unusual corner shop, most probably inserted in the later 19th century. The property is rendered and painted and has original late 18th century 6 over 6 and 3 over 3 sash windows.

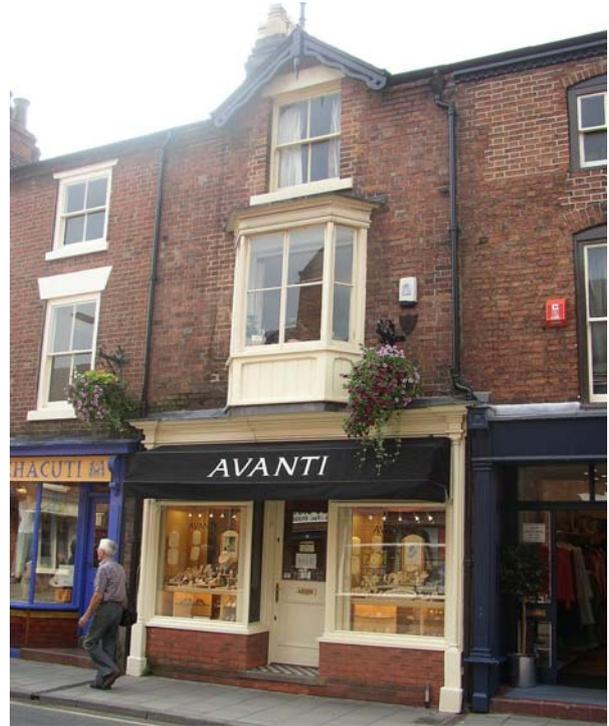
No 15-17 Dig Street

The majority of the remaining properties on Dig Street all appear to date from the mid-late 19th century. These are all constructed in brickwork with sash windows. Dig Street does have an example of a first floor canted bay window (above 'Avanti' – No 15-17). This particular property also has a small gablet with decorative painted bargeboards and finial. It is most probable that the central first floor window above 'Nigel's' (No 21) was originally

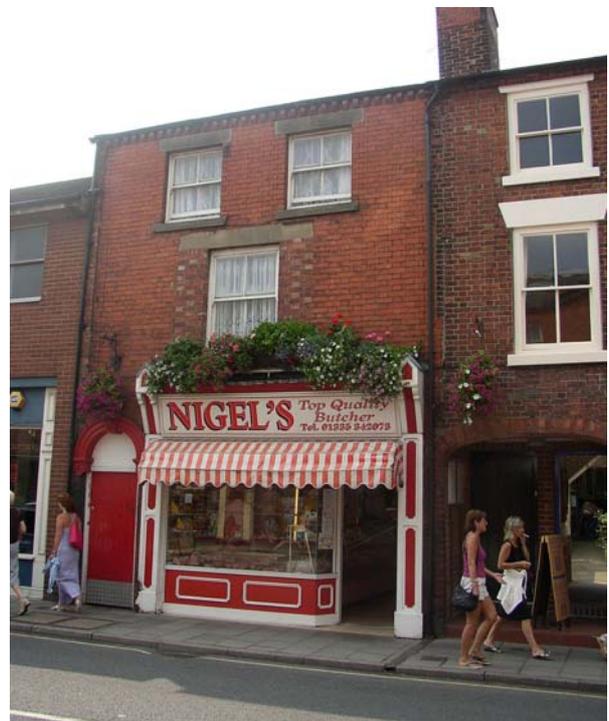
No 21 Dig Street

another canted bay window which has been removed and reformed to form a plain sash window.

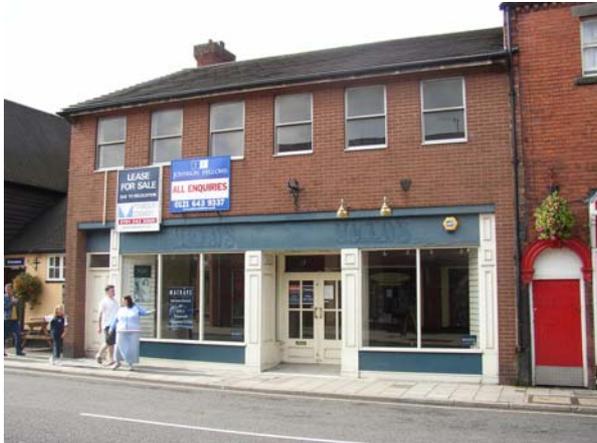
No 23-25 Dig Street

Dig Street displays three modern brick built commercial properties, all dating from the 1980-90s. Although they are constructed from brickwork they have little architectural merit in terms of fine decorative details and craftsmanship that can be found in most of the existing, historic properties.

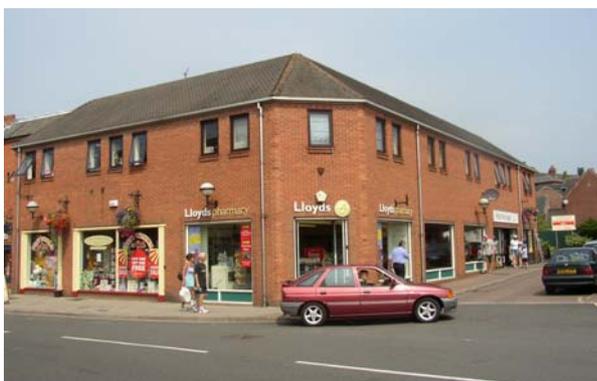
Hood's Yard

An historical characteristic of Dig Street is the number of gennels and alleyways leading to yards and buildings to the rear of the street frontage properties. These are open, in the form of a brick archway or are closed with a painted timber door.

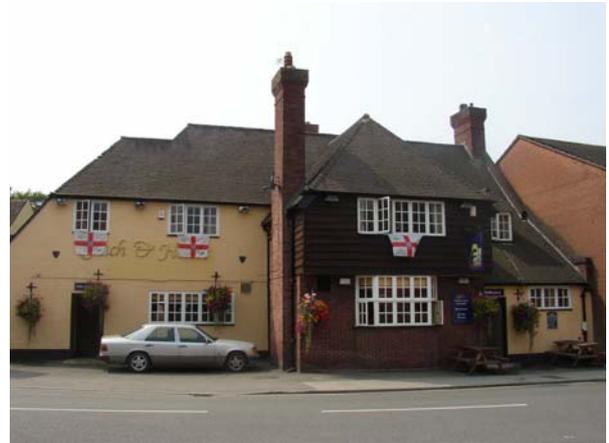
Coach & Horses PH

At the lower end of Dig Street is the Coach & Horses PH. This dates from the early 20th century and is in an architectural style that is reminiscent of the English vernacular revival. As a piece of architecture it relates more to the type of buildings in the south of England rather than mid

Derbyshire. Its stylistic characteristics are the tall brick chimneys, the hipped, tiled roofs, the general asymmetry of the elevation/composition and the multi-paned casement windows. It also contains an example of horizontal timber cladding – a wall treatment very uncharacteristic to the building tradition of this part of Derbyshire.

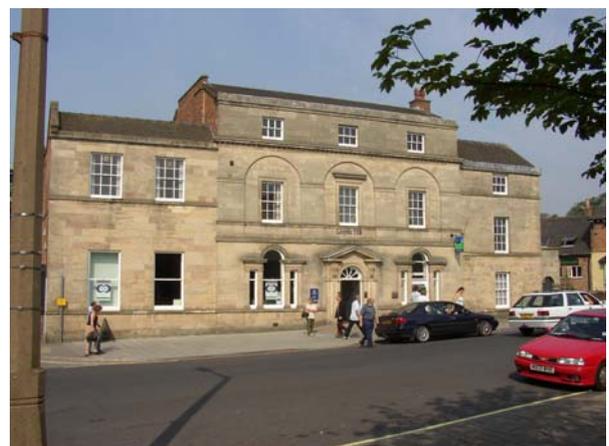
Lloyds TSB Bank

The present Conservation Area includes the historic stone bridge over the Henmore Brook and extends to include the Lloyds TSB Bank. This is housed in what was originally a fine town house constructed from ashlar stone with brickwork to the sides and rear. The property was designed by Joseph Pickford of Derby and dates from c.1780. The ostentatious display of architectural elements to the central block includes Venetian windows, a pedimented doorcase and sash windows set within blind arcading. It is most probable that the wings to each side of the main block are later additions – that to the right being earlier than that to the left. The brick chimneystacks have been altered and reduced.
